**PRELIMINARY ASSESSMENT
FOR
MILL CREEK TRIBUTARY
EPA ID No. ARN000606914
FORT SMITH, SEBASTIAN COUNTY, ARKANSAS**

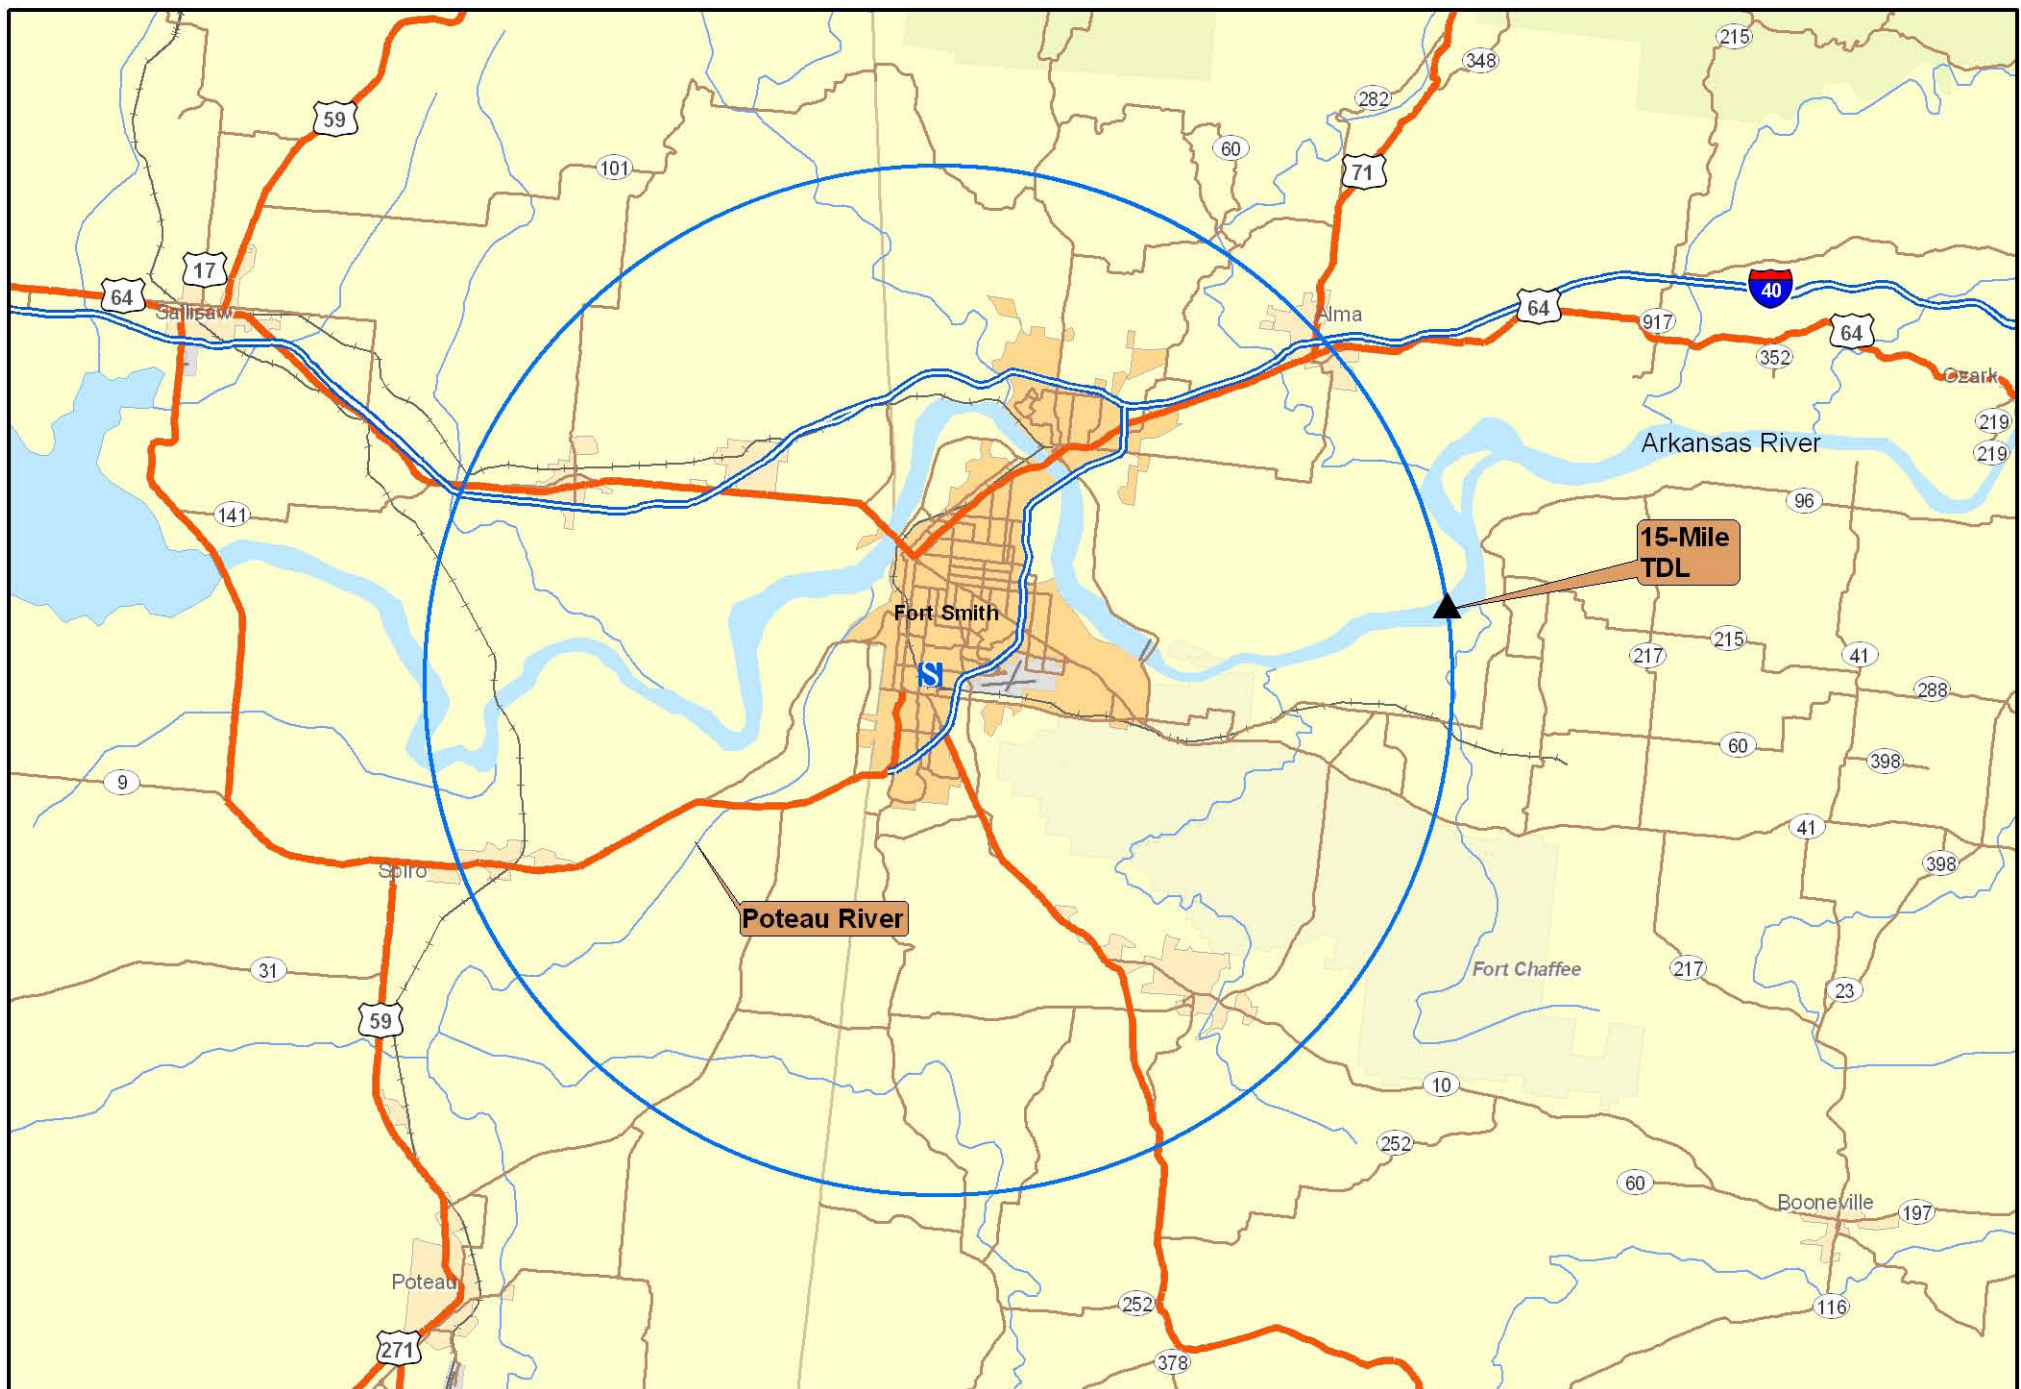
Mill Creek Tributary
15-Mile Radius and Total Distance Limit
Figure 3-2

Figure 3-2 illustrates the approximate 15-mile radius delineation used by the Department of Arkansas Heritage's Arkansas Natural Heritage Commission (ANHC) for the database search for threatened and endangered species and significant ecological communities and indicates the 15-mile TDL downstream from the Mill Creek Tributary site. The 15-mile TDL is within the Arkansas River, approximately 9.8 miles from the Poteau River confluence. **Figure 3-3** indicates the approximate initial and final PPE locations within the context of the area's general surface water ways.

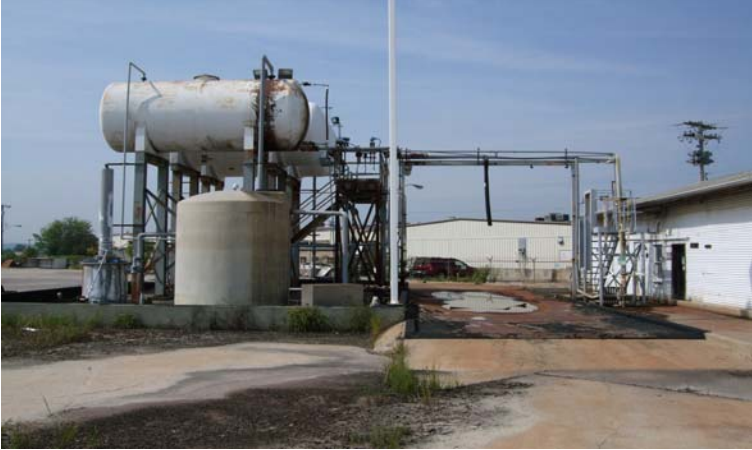
Description: Dowell Schlumberger AST area; and truck scales; facing southwest			
Photo #	2	of	33				Date:	08/27/09	Time:	11:15 AM

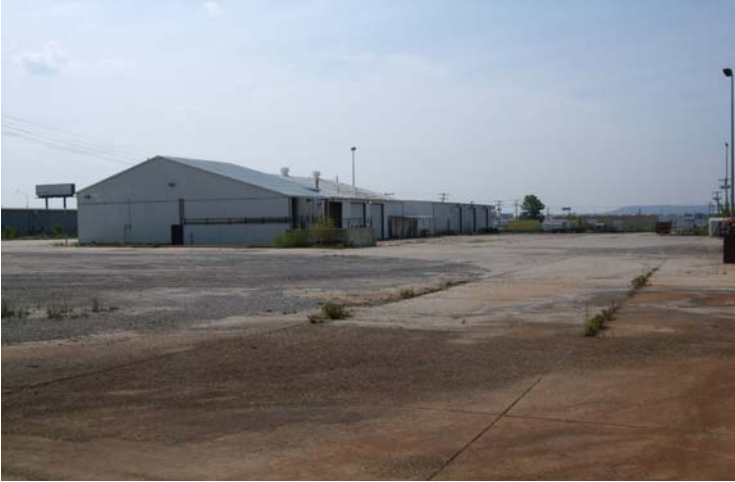
Description: Dowell Schlumberger Maintenance Building; facing southeast			
Photo #	3	of	33				Date:	08/27/09	Time:	11:17 AM

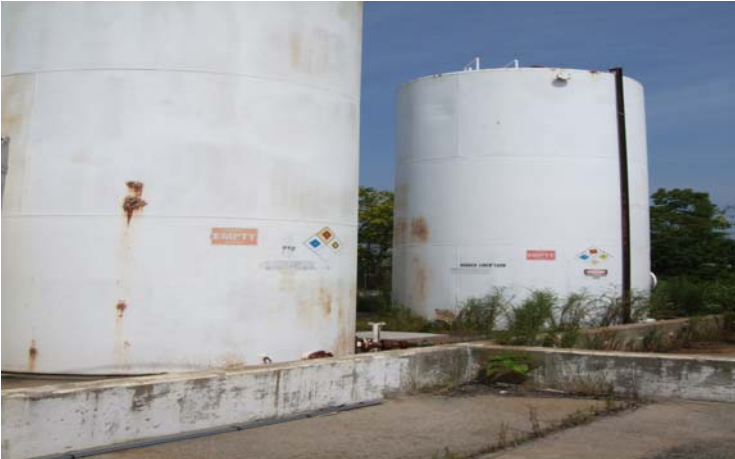
Description: Dowell Schlumberger AST area; facing northwest

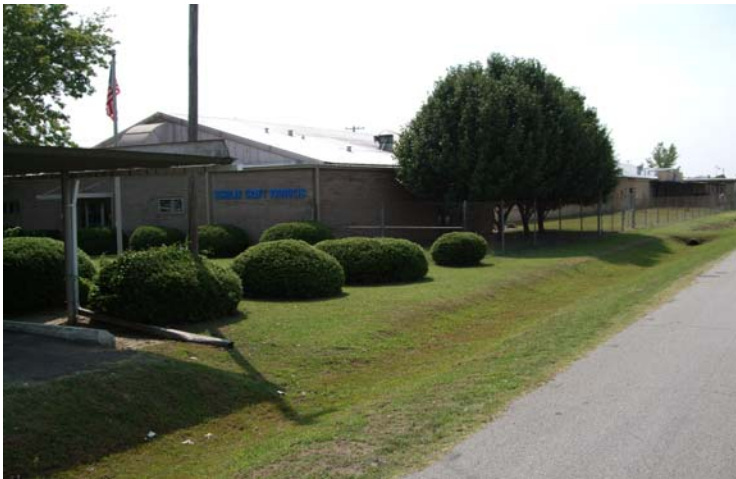
Description: Scholar Craft entrance; storm water conveyance parallel to 34 th Street		
Photo #	5	of	33		Date:	08/27/09	Time:	11:30 AM

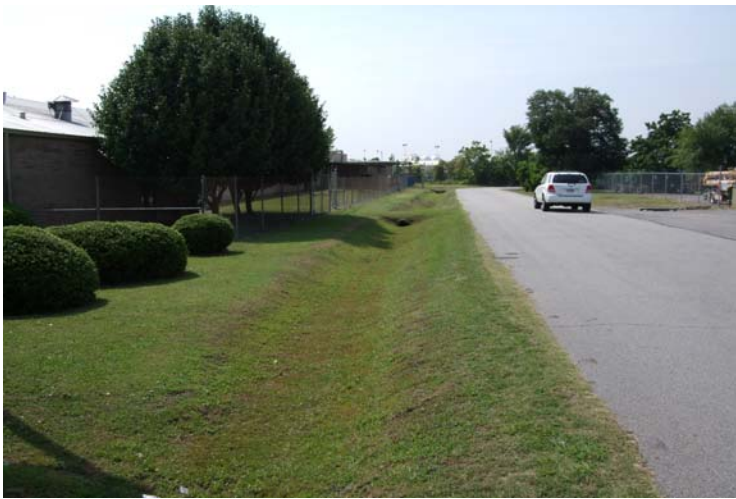
Description: Scholar Craft; storm water conveyance parallel to 34 th street; facing west		
Photo #	6	of	33		Date:	08/27/09	Time:	11:41 AM

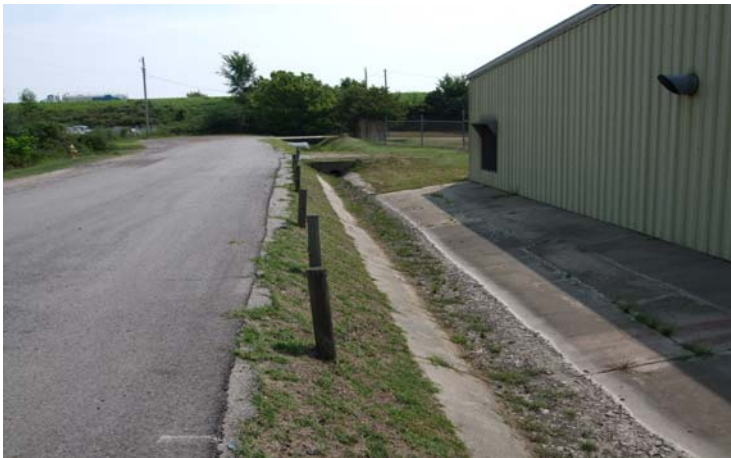
Description: Scholar Craft; storm water conveyance adjacent to manufacturing area; facing east

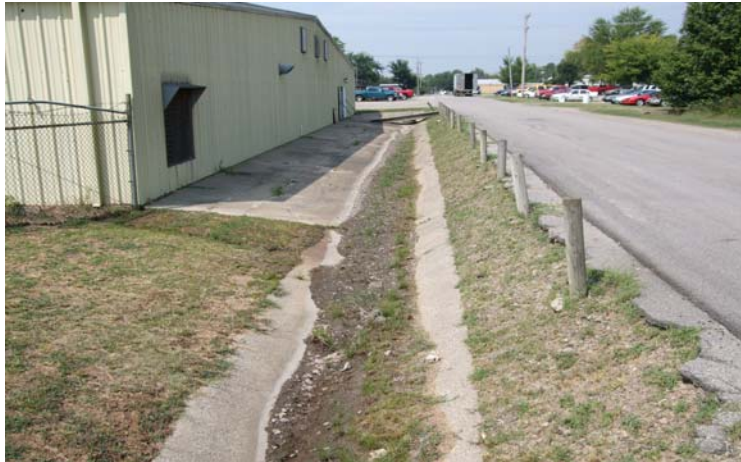
Description: Scholar Craft; storm water conveyance adjacent to manufacturing area; Vicksburg Street facing west				
Photo #		8	of	33			Date:		08/27/09		Time:	11:59 AM

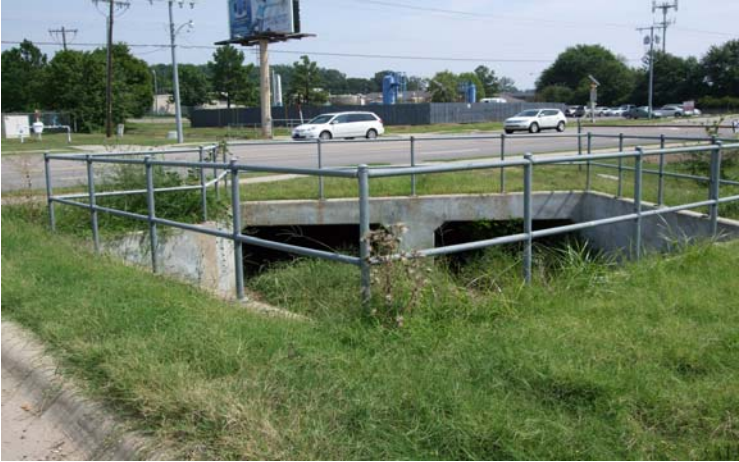
Description: Mill Creek Tributary culvert under Phoenix Avenue; facing northeast		
Photo #	10	of	33		Date:	08/27/09	Time:	12:00 PM

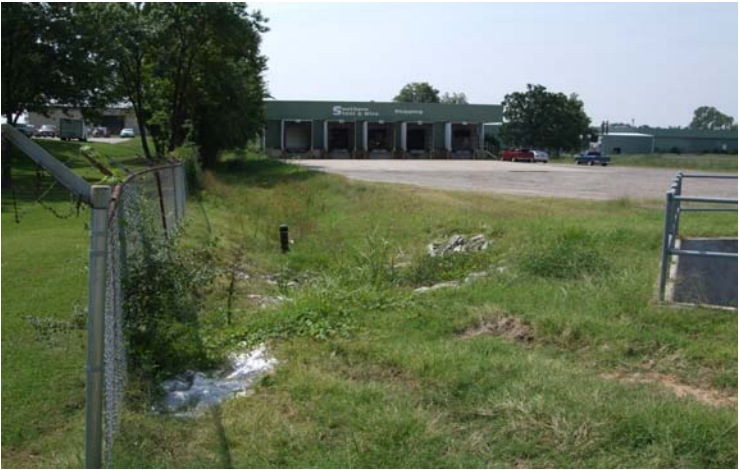
Description: Southern Steel & Wire truck loading docks; facing southwest from Mill Creek Tributary culvert under Phoenix Avenue		
Photo #	11	of	33		Date:	08/27/09	Time:	12:07 PM

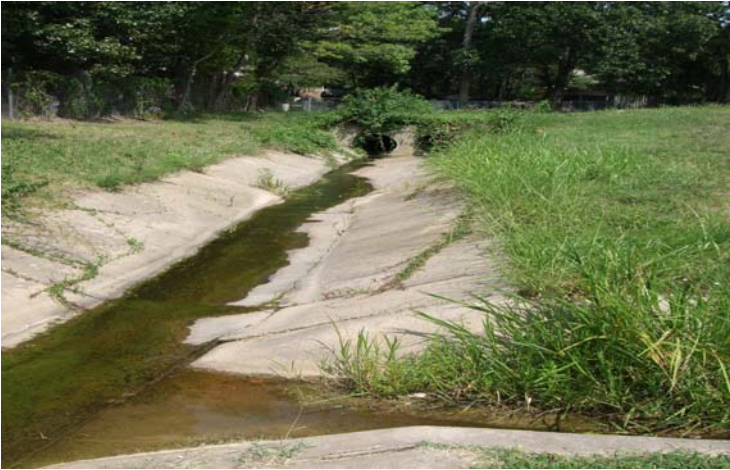
Description: Near headwaters of Mill Creek Tributary; facing north between Orr Elementary School and Covington Court Health and Rehabilitation Center

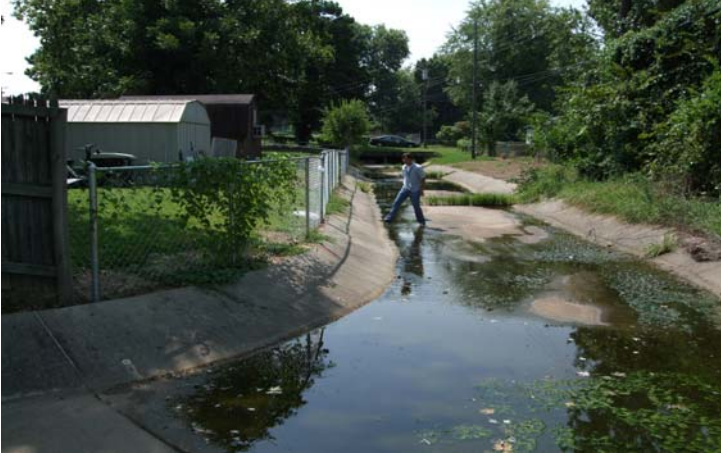
Description: Mill Creek Tributary within residential area between 33 rd and 34 th Streets; facing south towards Savannah Street		
Photo #	13	of	33		Date:	08/27/09	Time: 12:17 PM

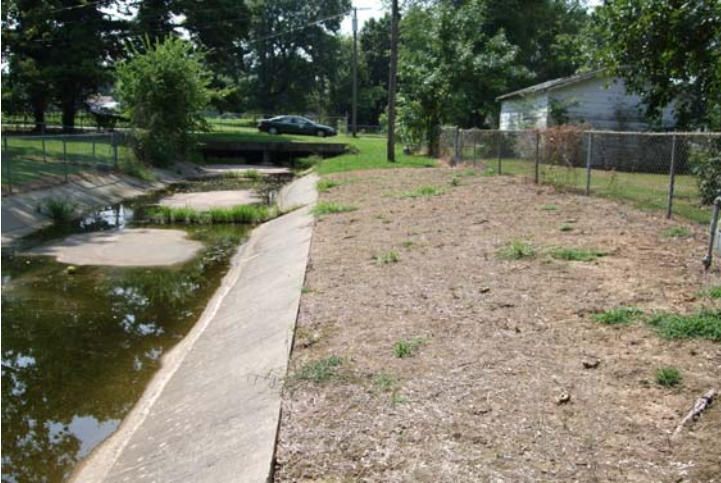
Description: Mill Creek Tributary within residential area between 33 rd and 34 th Streets; dead vegetation; facing south towards Savannah Street		
Photo #	14	of	33		Date:	08/27/09	Time: 12:20 PM

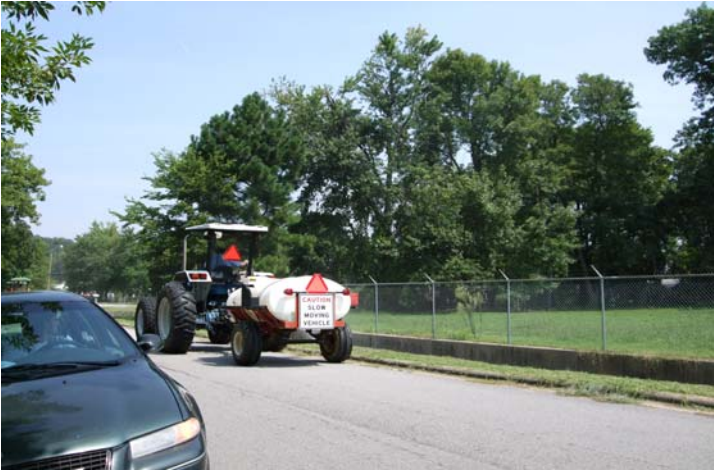
Description: Mill Creek Tributary on west side of Southern Steel & Wire; mosquito control application; facing north on 33 rd Street

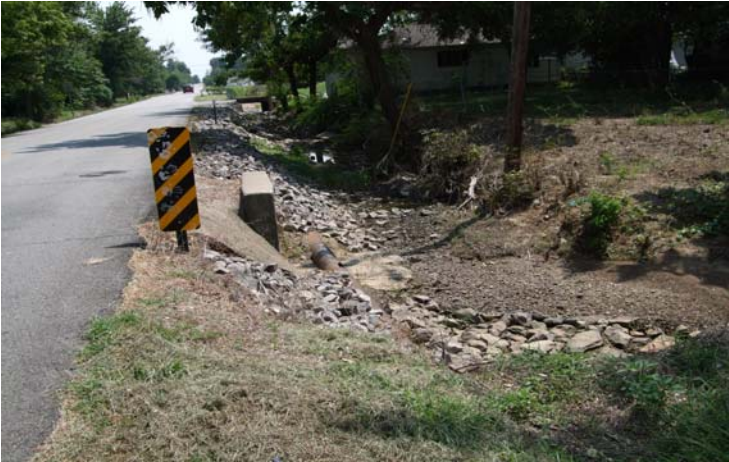
Description: Mill Creek Tributary in residential area between 30 th and 29 th Streets; facing northeast		
Photo #	17	of	33		Date:	08/27/09	Time:	12:34 PM
 						Description: Mill Creek Tributary in residential area between 30 th and 29 th Streets; facing south from Tulsa Street

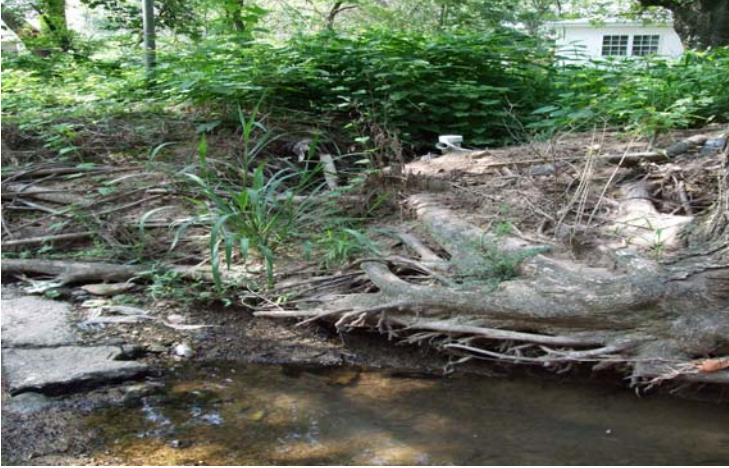
The entire length of the Mill Creek Tributary and the storm water conveyances draining into it were not visually inspected during the site reconnaissance visits. An extensive portion of the tributary runs through the backyards of multiple private residences, and numerous storm water conveyances also drain private yards. As shown in Section 6.0, Photo Numbers 12 and 13, areas of dead vegetation suggesting herbicide application were noted along some fence lines, as was one large area of unvegetated ground adjacent to the tributary. A Fort Smith road maintenance crew was engaged in mosquito control activities along portions of the tributary during the August 27, 2009 site reconnaissance visit (see Photo 14). A person residing near the tributary volunteered information during this site reconnaissance visit that the tributary and/or storm water conveyances regularly overflowed during periods of heavy rain, and expressed a concern about an unidentified underground pipe leaking into a drainage ditch (see Photo 15) (Ref. 26). A small boat with the engine positioned directly over the tributary was noted in one yard. Additionally, a leaking polyvinyl chloride (PVC) pipe in the yard of

a residence was noted draining directly into the tributary (see Photo 18); a strong sewage odor was noted at this location.

Description: PVC pipe in residential yard leaking into Mill Creek Tributary; south of Tulsa Street between 30 th and 29 th Streets, north of Utica Street		
Photo #	19	of	33		Date:	08/27/09	Time: 12:39 PM

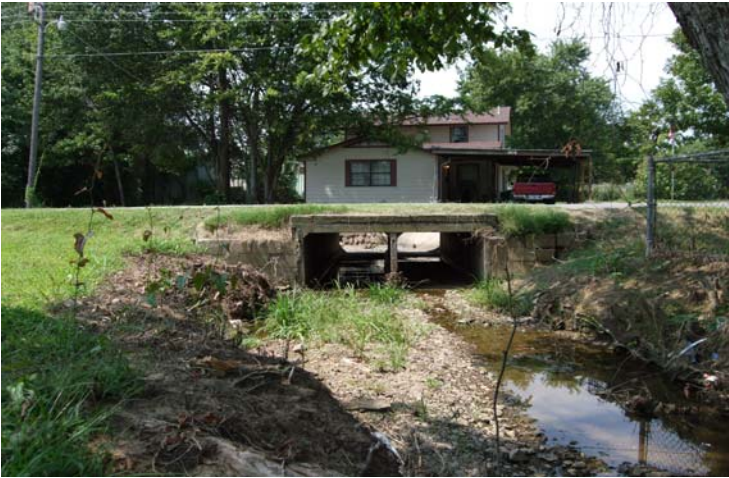
Description: Mill Creek Tributary in residential area; facing west towards 29 th Street between Tulsa and Utica Streets		
Photo #	20	of	33		Date:	08/27/09	Time: 1:04 PM

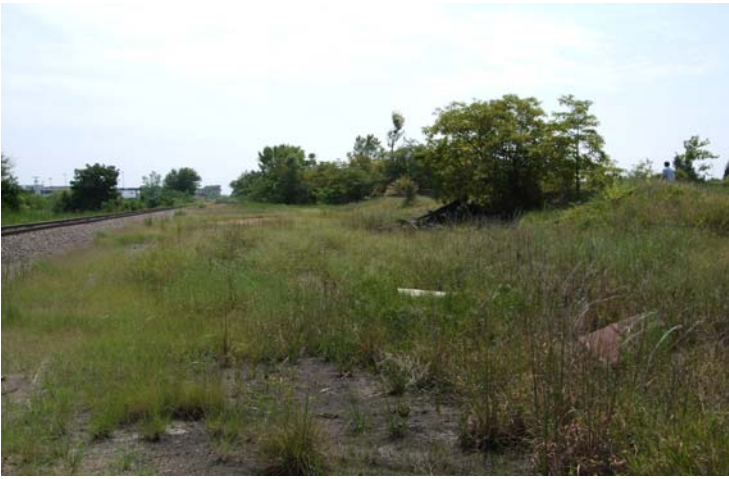
Description: Drainage area parallel to railroad tracks on northeast portion of Jenny Lind property; facing southeast

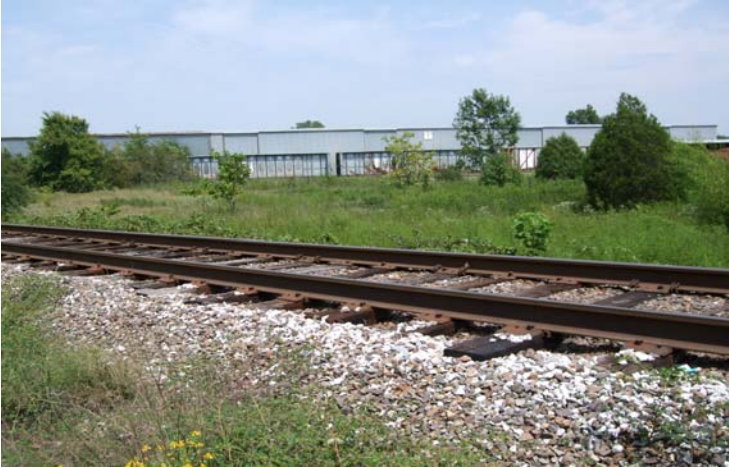
Description: Railroad track from north portion of Jenny Lind property; view of Fort Smith Warehouse Solutions; facing northeast		
Photo #	22	of	33		Date:	08/27/09	Time:	1:09 PM

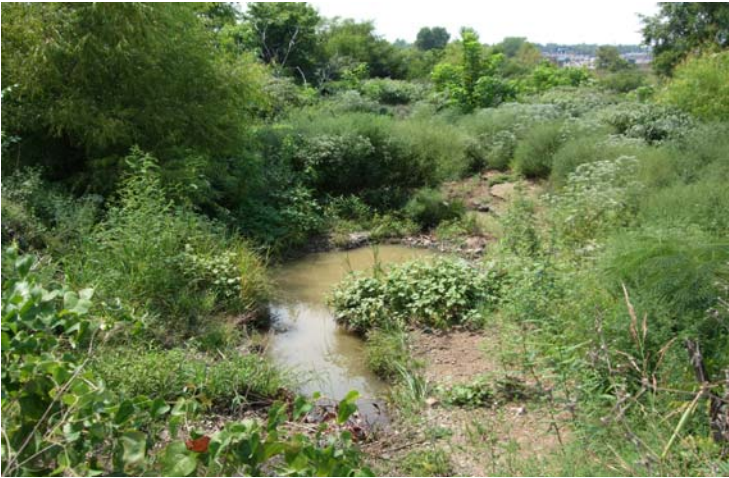
Description: Mill Creek Tributary on Jenny Lind property; general vicinity of Beaver Pond; facing southwest from railroad track		
Photo #	23	of	33		Date:	08/27/09	Time:	1:11 PM

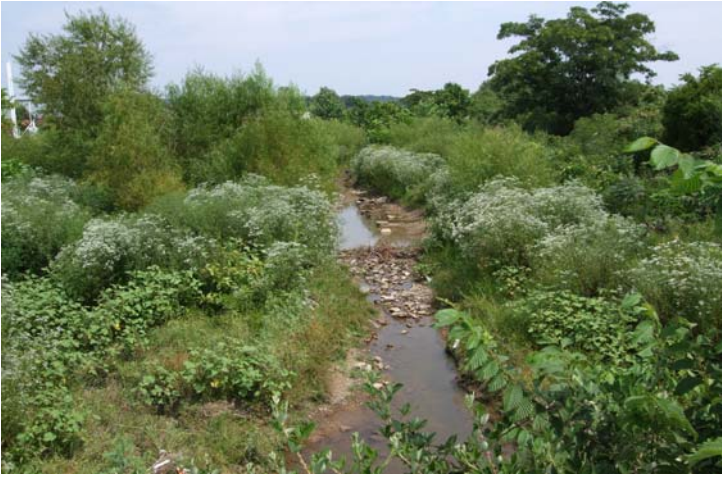
Description: Mill Creek Tributary northeast of Jenny Lind property; general vicinity of offsite sediment sample location; facing east from railroad track

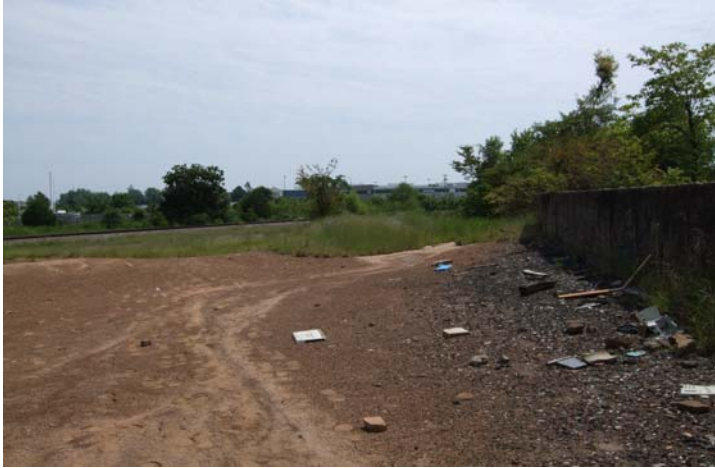
Description: Northeast portion of Jenny Lind property; concrete smelter foundation on right side of photo, railroad track on left side of photo; evidence of drift flooding		
Photo #	25	of	33		Date:	08/27/09	Time:	1:12 PM

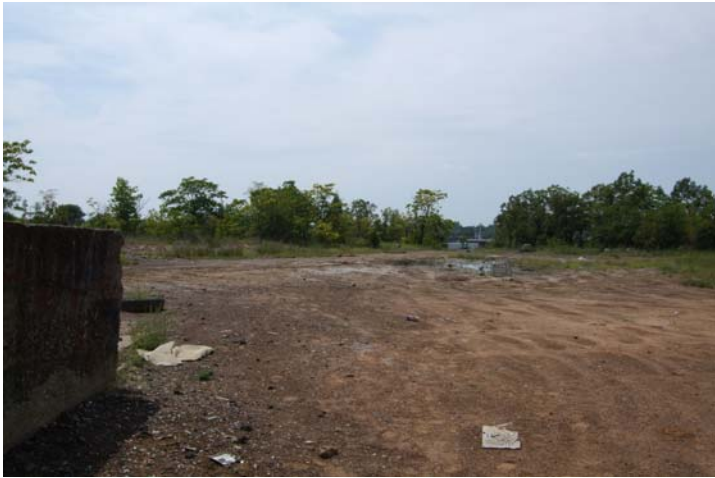
Description: North center portion of Jenny Lind property; concrete smelter foundation on left side of photo; evidence of drift flooding; unvegetated area; facing Mill Creek Tributary		
Photo #	26	of	33		Date:	08/27/09	Time:	1:15 PM

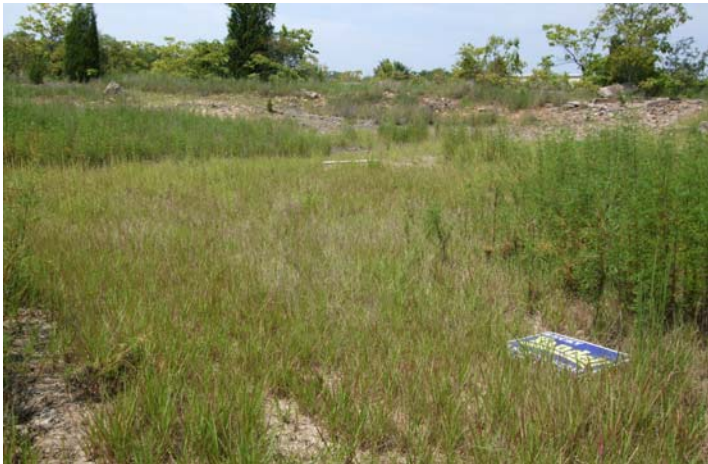
Location:	Mill Creek Tributary							
Photographer:	Michael Gates		Witness:	Mary Pearson		Weather:	Sunny, Dry	
Photo #	27	of	33		Date:	08/27/09	Time:	1:25 PM

Description: Center portion of Jenny Lind property; facing northeast

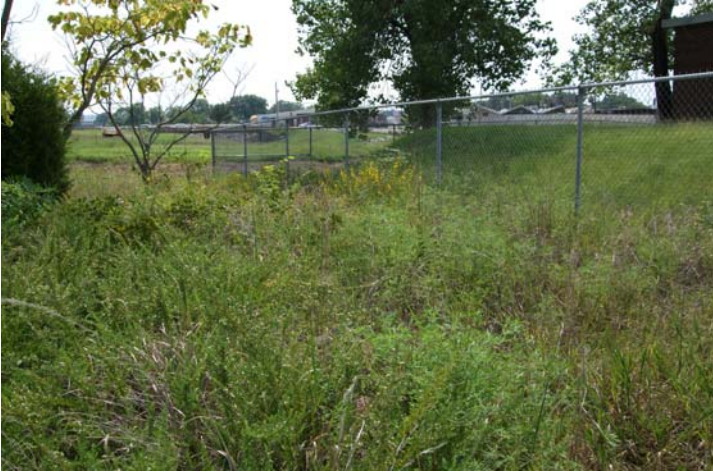
Description: Southwest corner of Jenny Lind property; facing Mill Creek Tributary near PPE at Mill Creek		
Photo #	28	of	33		Date:	08/27/09	Time:	1:27 PM

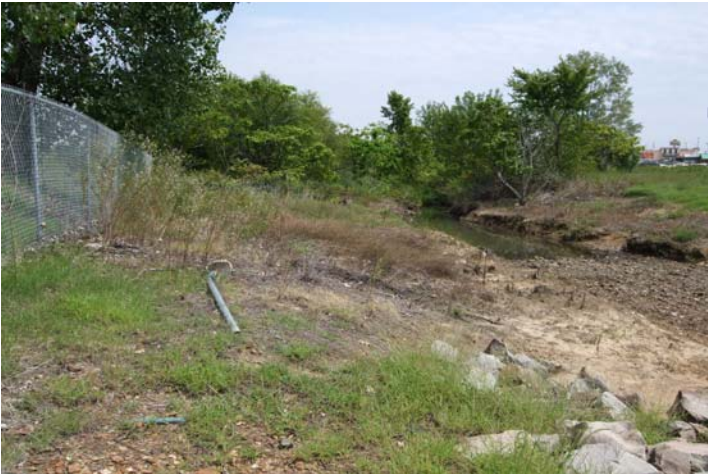
Description: Mill Creek Tributary; Wal-Mart Supercenter area on left side of photo; facing east from near PPE at Mill Creek;		
Photo #	29	of	33		Date:	08/27/09	Time:	1:27 PM

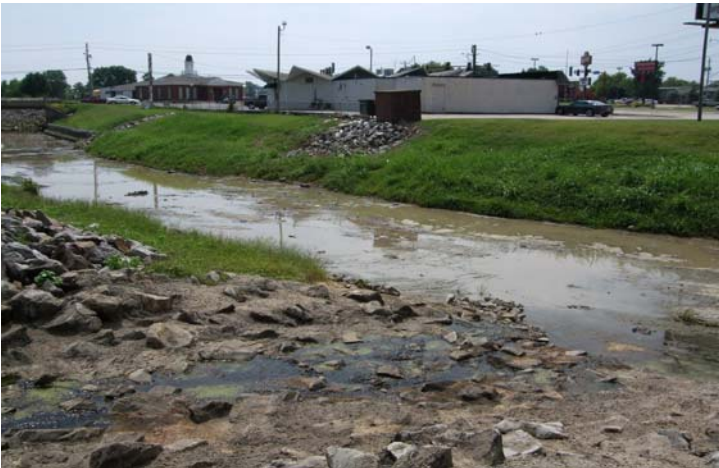
Location:		Mill Creek Tributary													
Photographer:		Michael Gates			Witness:		Mary Pearson			Weather:		Sunny, Dry			
Photo #		30	of	33				Date:		08/27/09		Time:		1:32 PM

Description: Mill Creek; facing south, southwest

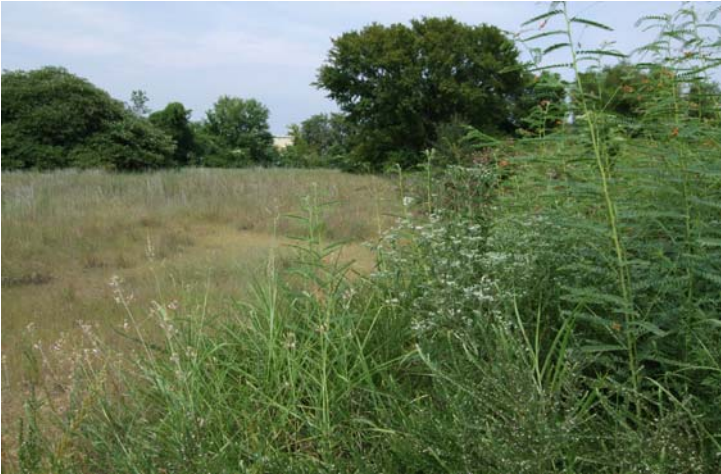
<p>Description:</p> <p>Open field south of Mill Creek Tributary; shallow gullies leading north from south-adjacent property</p>					
Photo #		31	of	33				Date:		08/27/09		Time:		1:32 PM

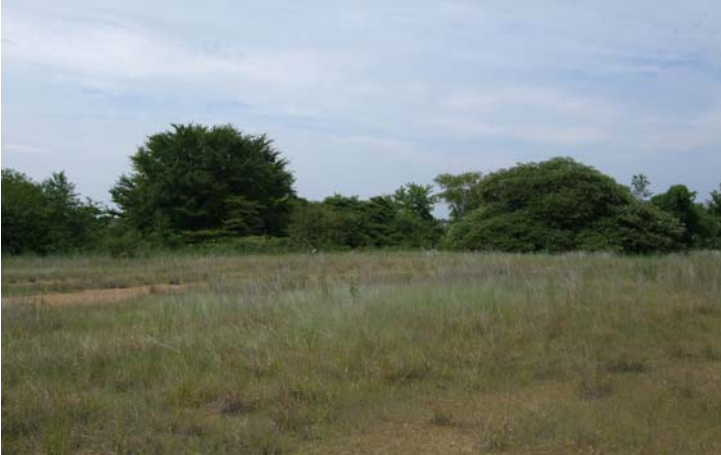
<p>Description:</p> <p>Open field south of Mill Creek Tributary; tree line of storm water conveyance from west border of Wal-Mart Supercenter leading into Mill Creek Tributary</p>					
Photo #		32	of	33				Date:		08/27/09		Time:		1:40 PM

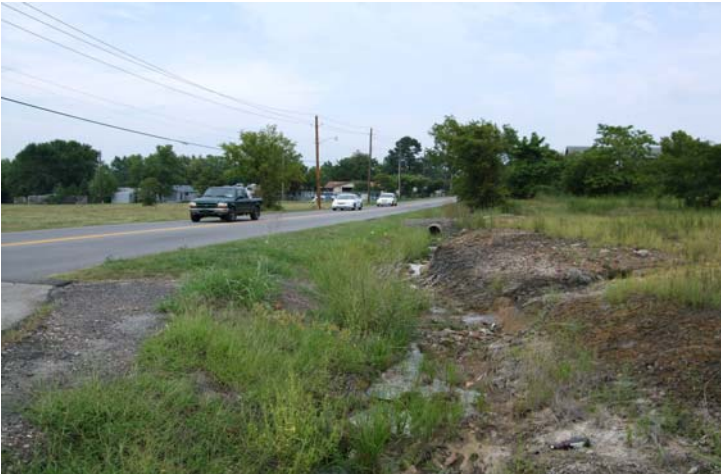
<p>Description:</p> <p>Storm water conveyance parallel to Jenny Lind Road on west border of Jenny Lind property; facing north</p>

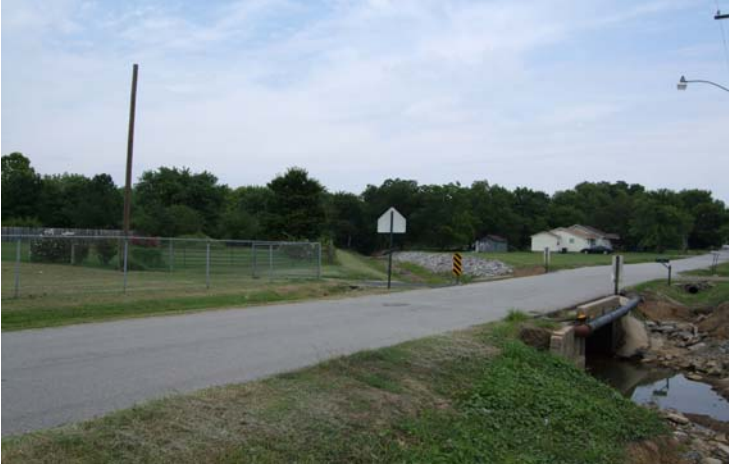
<u>Description:</u>		
						Mill Creek Tributary flowing under Vicksburg Street; facing north, northeast from outside Northwest Fire Protection maintenance yard
